**Flood Control Project Maintenance
Levee Inspections**
LMA District Cover Sheet
Spring 2019 Levee Inspection Results

Merced Streams Group

Spring 2019 Levee Inspection Results

Waterway			Bank	Unit Miles
Unit No. 01 Black Rascal Diversion			Right	1.61
	Spring (March - May)	Summer (June - August)	(September - November) Fall	Winter (December - February)
Unit Maintenance Rating (Fall Only)				
Date of Inspection	4/30/2019 - 4/30/2019			
DWR Inspector	Corey Fujitani			
Accompanied By

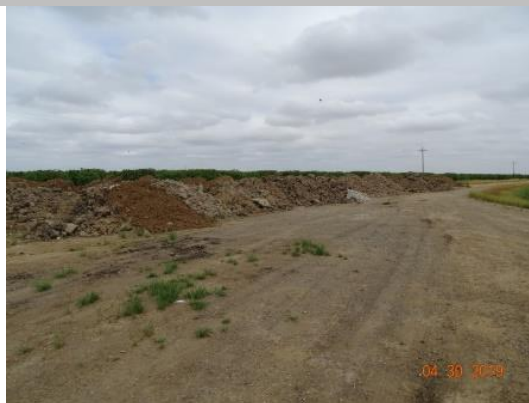
Photo 1 of 1 : SP_2019_NA0013_331_13_20190501_00014.jpg

View of material piled on levee crown. (Spring 2019)

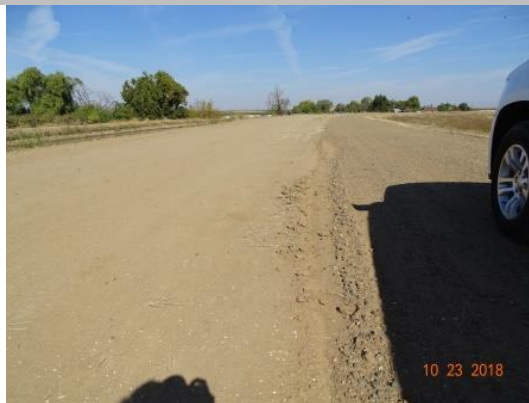
Photo 1 of 2 : SP_2019_NA0013_331_8_20190307_00004.jpg

LM Start	0.27	Rating **	A/W	Issue No.	8
LM End	1.62	Issue Type +	Ma	Location *	CR
Category	Earthen Levee			GPS Latitude/Longitude	
				Start	End
Item	Crown Surface / Depressions / Rutting			37.318525 °	37.337176 °
				-120.396598 °	-120.396531 °
DWR ID	DWR_NA0013_01_s_2018_8				
Comment Code					
C2 : Repair depressions or ruts in the crown or slope.					
Inspector Comment					
Vehicle tracks and rutting on the crown should be repaired.

View of vehicle tracks on levee crown. (Fall 2018)

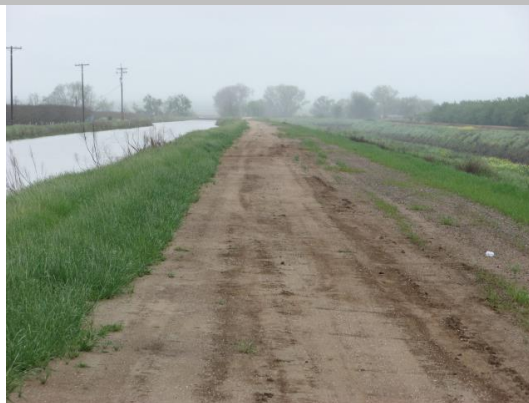
Photo 2 of 2 : SP_2019_NA0013_331_8_20190307_00005.jpg

LM Start	0.27	Rating **	A/W	Issue No.	8 (cont)	
LM End	1.62	Issue Type +	Ma	Location *	CR	
Category	Earthen Levee			GPS Latitude/Longitude		
				Start		End
Item	Crown Surface / Depressions / Rutting			37.318525 °		37.337176 °
				-120.396598 °		-120.396531 °
DWR ID	DWR_NA0013_01_s _ 2018_8					
Comment Code						
C2 : Repair depressions or ruts in the crown or slope.						
Inspector Comment						
Vehicle tracks and rutting on the crown should be repaired.

Looking downstream at typical view of levee crown (Spring 2018)

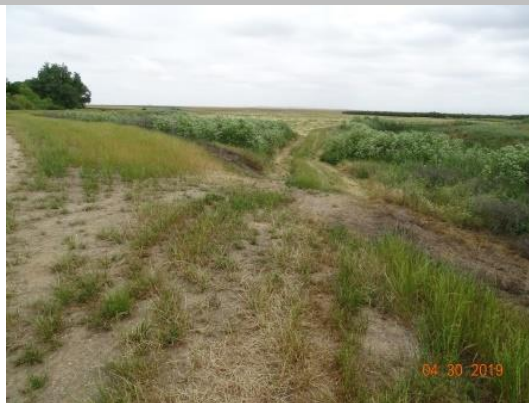
Photo 1 of 1 : SP_2019_NA0013_331_18_20190501_00017.jpg

View of ramp on waterside slope looking Northeast. (Spring 2019)

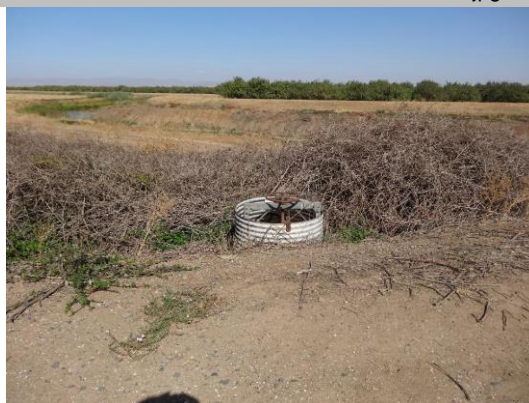
Photo 2 of 3 : UCIP_SP_2019_41672_35210.jpg

LS view: overview of CM pipe riser with slide gate. Dense vegetation on landside.

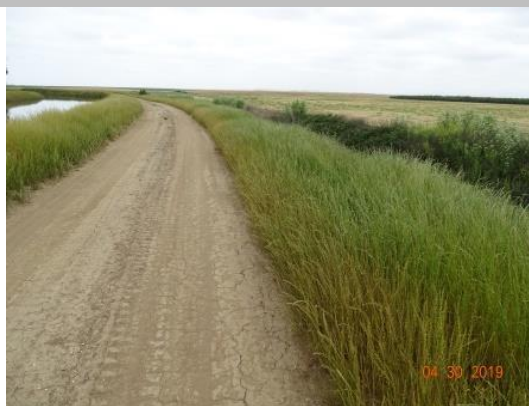
Photo 1 of 1 : SP_2019_NA0013_331_19_20190501_00018.jpg

LM Start	1.32	Rating **	U	Issue No.	19
LM End	1.58	Issue Type +	Ma	Location *	WS
Category	Earthen Levee			GPS Latitude/Longitude	
				Start	End
Item	Vegetation			37.333205 °	37.336734 °
				-120.395142 °	-120.396542 °
DWR ID	DWR_NA0013_01_s_2019_19				
Comment Code					
V1 : Control annual grass and weeds on the levee slopes and easements.					
Inspector Comment

View of waterside slope looking upstream. (Spring 2019)

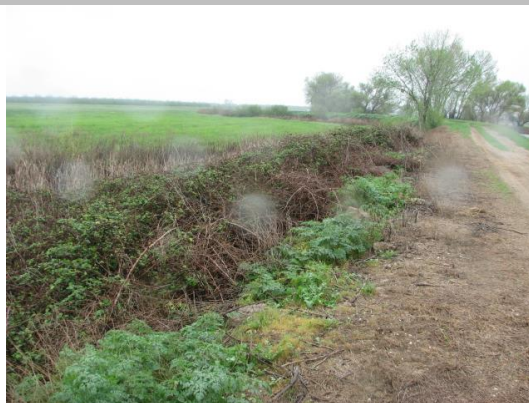
Photo 1 of 2 : SP_2019_NA0013_331_7_20190307_00002.jpg

Looking downstream at wild roses on waterward slope. (Spring 2018)

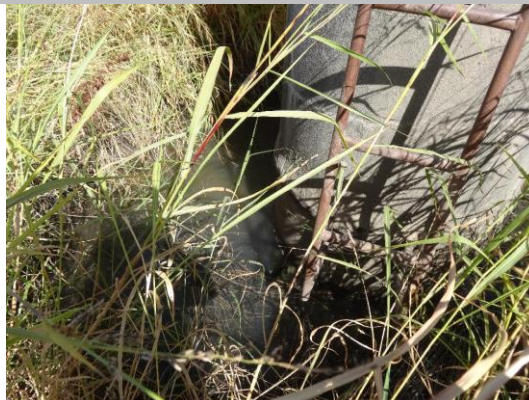
Photo 3 of 3 : UCIP_SP_2019_21263_35764.jpg

WS view: concrete standpipe with water ponding at its base.

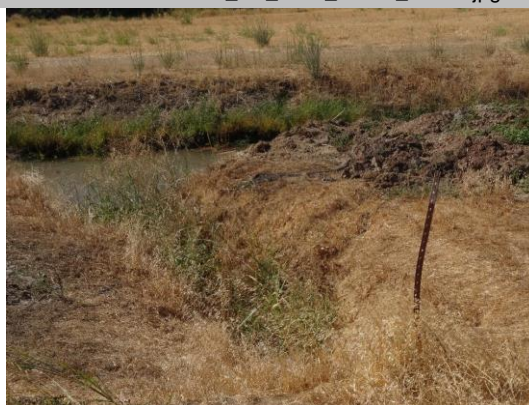
Photo 1 of 3 : UCIP_SP_2019_20946_35266.jpg

WS view: cobble spillway and channel on waterside.

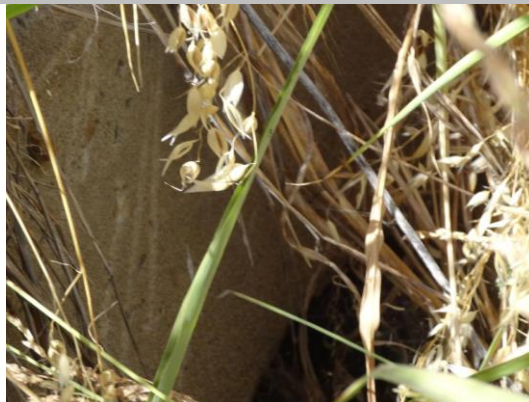
Photo 3 of 3 : UCIP_SP_2019_20946_35264.jpg

LS view: concrete headwall and CM pipe. Inlet needs cleaning.

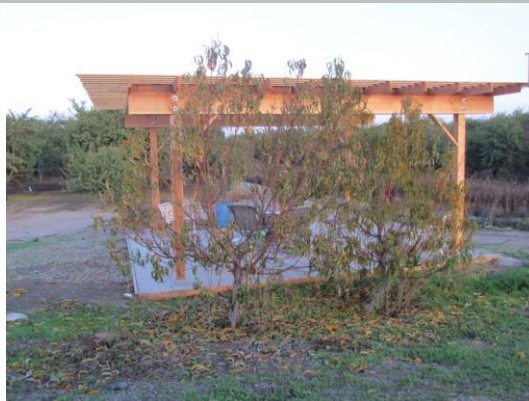
Photo 2 of 4 : SP_2019_NA0013_332_24_20190307_00014.jpg

Another view of unauthorized structure.

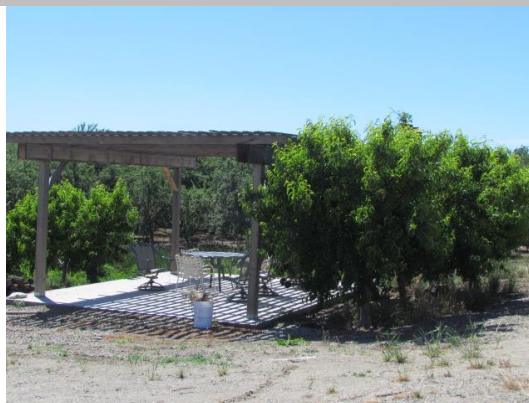
Photo 4 of 4 : SP_2019_NA0013_332_24_20190307_00016.jpg

No change 5-2017.

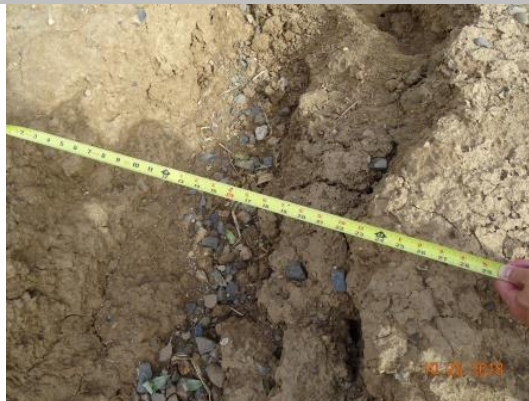
Photo 3 of 3 : SP_2019_NA0013_332_15_20190307_00007.jpg

Measurement across erosion at widest point. (Fall 2018)

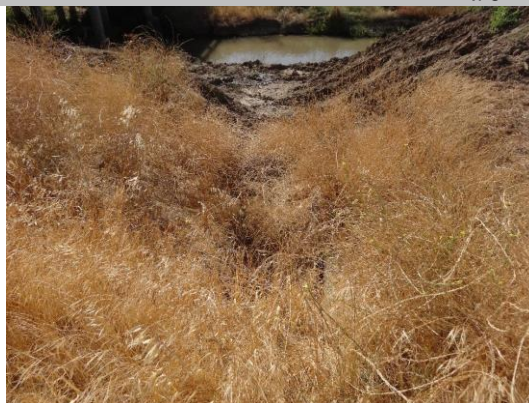
Photo 1 of 3 : UCIP_SP_2019_42993_35310.jpg

WS view: overview of outlet area and channel. Debris and vegetations on spillway.

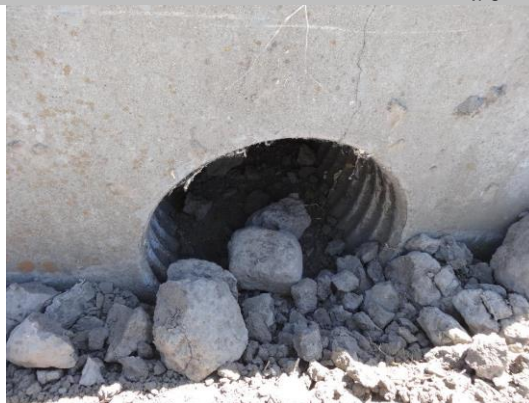
Photo 3 of 3 : UCIP_SP_2019_21063_35500.jpg

LS view: closer view of CM pipe. Inlet needs cleaning & clearing.

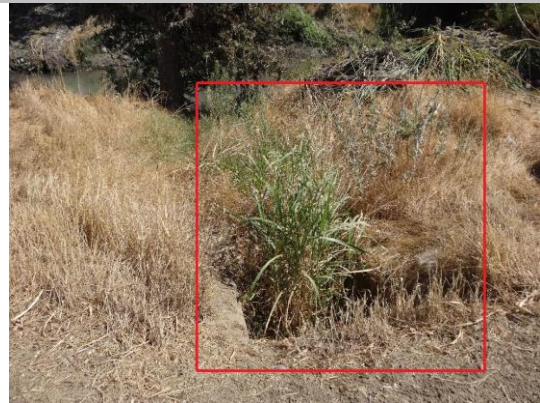
Photo 1 of 3 : UCIP_SP_2019_21064_35506.jpg

WS view: cobble spillway and channel on waterside. Dense vegetation on levee slope and spillway.

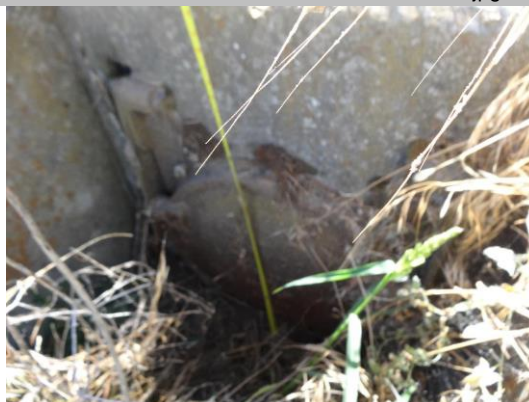
Photo 2 of 3 : UCIP_SP_2019_42991_35750.jpg

WS view: U typed concrete headwall, CM pipe, and flap gate. Vegetation and silt need to be cleared.

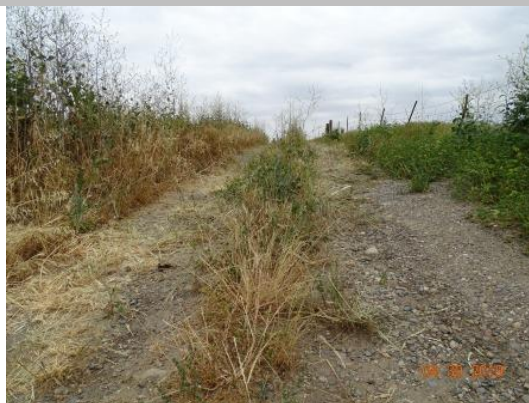
Photo 2 of 2 : SP_2019_NA0013_334_25_20190503_00040.jpg

View of vegetation on levee crown looking upstream. (Spring 2019)

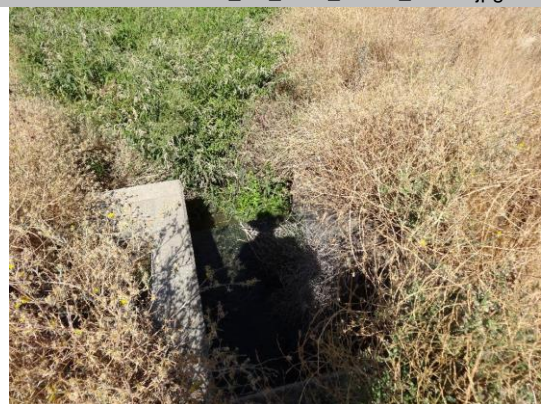
Photo 1 of 3 : UCIP_SP_2019_21126_35652.jpg

WS view: concrete spillway and channel on waterside. Dense vegetation on levee slope and spillway.

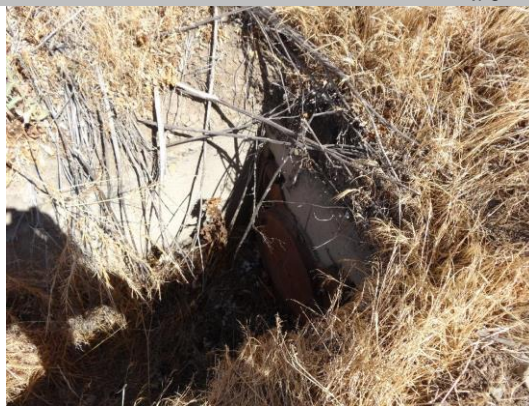
Photo 1 of 3 : UCIP_SP_2019_52888_35709.jpg

WS view: concrete spillway and channel on waterside. Dense vegetation on levee slope and spillway.
